## Update "With-Site-Visit" Reserve Study

### High Forest Ranch HOA Colorado Springs, CO

**Report #: 10789-5**  
**For Period Beginning: January 1, 2020**  
**Expires: December 31, 2020**

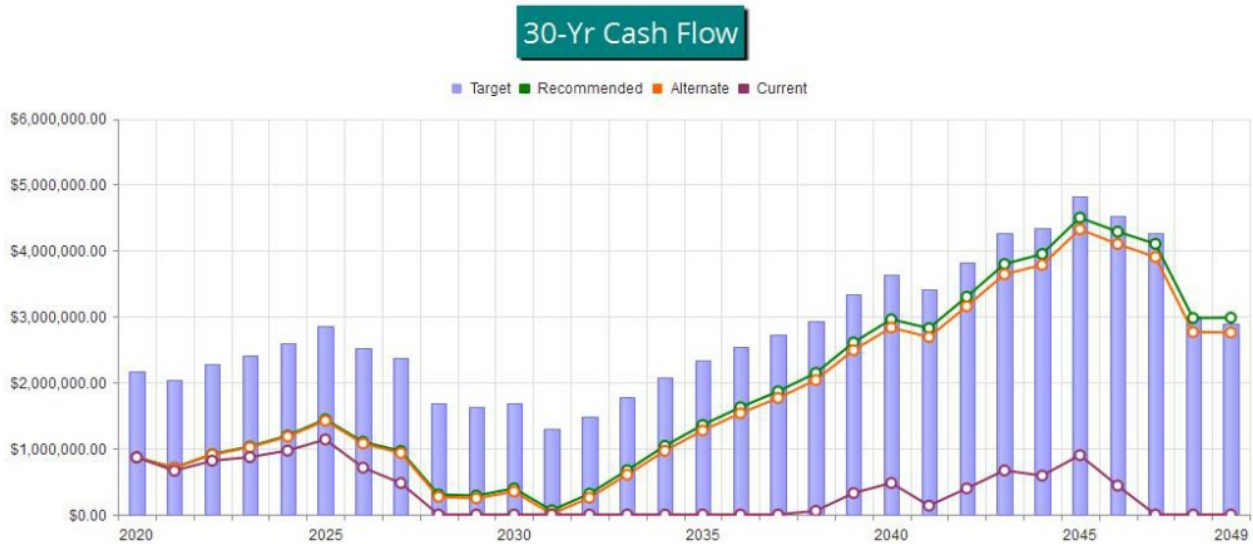
Figure 3

The following chart shows your Reserve balance under our recommended Full Funding Plan, an alternate Baseline Funding Plan, and at your current budgeted contribution rate, compared to your always-changing Fully Funded Balance target.

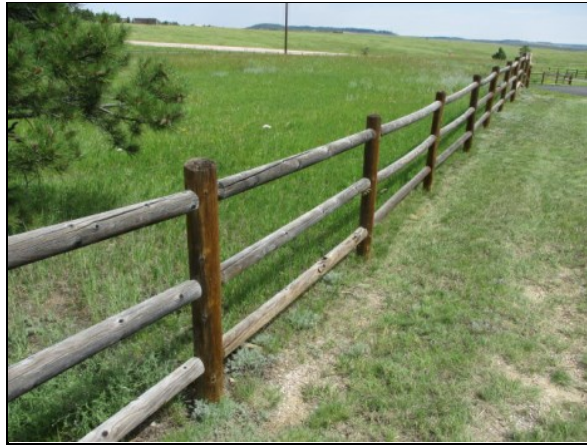
Useful Life:  
2 years

Remaining Life:  
1 years

Best Case: \$ 9,000

Worst Case: \$ 11,000

| # | Component | Quantity | Useful Life | Rem. Useful Life | Current Cost Estimate | |
|---|---|---|---|---|---|---|
| 2157 | Site Rail: Wood - Replace - 5% | 5% of ~ 9,000 LF | 2 | 1 | \$9,000 | \$11,000 |

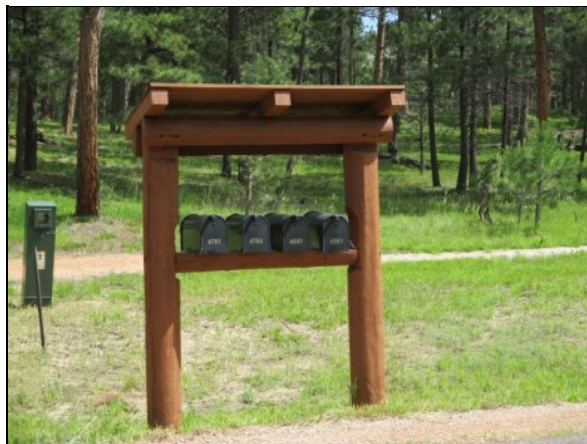
Useful Life:  
10 years

Remaining Life:  
7 years

Best Case: \$ 4,800

Worst Case: \$ 6,900

| # | Component | Quantity | Useful Life | Rem. Useful Life | Current Cost Estimate | |
|---|---|---|---|---|---|---|
| 2165 | Mailbox Kiosks - Repair | ~ (40) Mailbox Stations | 10 | 7 | \$4,800 | \$6,900 |

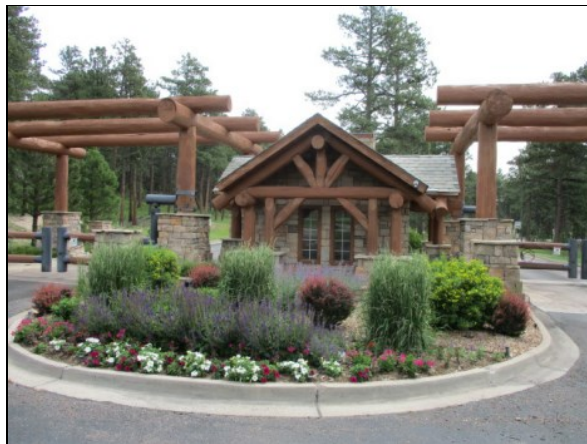
Useful Life:  
6 years

Remaining Life:  
4 years

Best Case: \$ 3,000

Worst Case: \$ 5,000

| # | Component | Quantity | Useful Life | Rem. Useful Life | Current Cost Estimate | |
|---|---|---|---|---|---|---|
| 2189 | Wood Surfaces: Entry/Kiosks - Stain | (40) Kiosks, (2) Bldgs. | 6 | 4 | \$3,000 | \$5,000 |

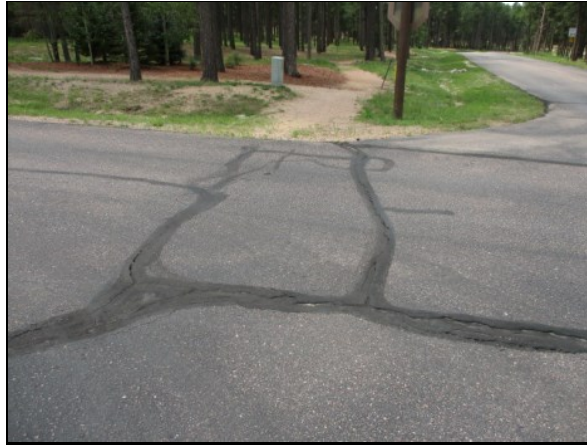
Useful Life:  
1 years

Remaining Life:  
0 years

Best Case: \$ 16,000

Worst Case: \$ 18,000

| # | Component | Quantity | Useful Life | Rem. Useful Life | Current Cost Estimate | |
|---|---|---|---|---|---|---|
| 2124 | Asphalt - Crack Fill/Seal | ~ 1,210,619 GSF | 1 | 0 | \$16,000 | \$18,000 |

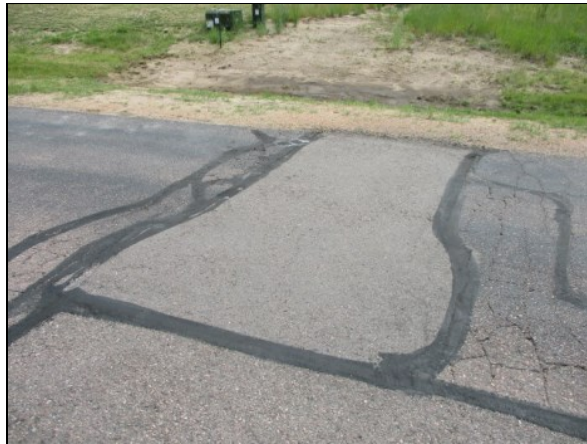
Useful Life:  
1 years

Remaining Life:  
0 years

Best Case: \$ 18,000

Worst Case: \$ 22,000

| # | Component | Quantity | Useful Life | Rem. Useful Life | Current Cost Estimate | |
|---|---|---|---|---|---|---|
| 2124 | Asphalt Maintenance - Repairs | ~ 1,210,619 GSF | 1 | 0 | \$18,000 | \$22,000 |

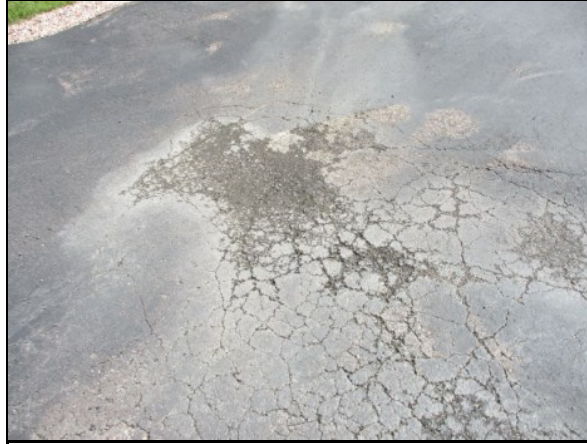
Comments: Overall, poor conditions were observed. Useful life below assumes regular seal coating and repairs. The lack of seal coating and repairs can greatly decrease the asphalt's useful life. Resurfacing is typically one of the larger expense items in a reserve study. When need to resurface is apparent within a couple of years consult with geotechnical engineer for recommendations specifications / scope of work and project oversight. As routine maintenance keep surfaces clean and free of debris ensure that drains are free flowing repair cracks and clean oil stains promptly. Assuming proactive maintenance plan to resurface at roughly the time frame below. If regular maintenance and sealing is deferred client may need more extensive repair and replacement projects. Funding below assumes that asphalt has adequate subgrade as well as asphalt fill depth. If fill depth is less than 2" client may need to consider a remove and replacement project which can increase costs by 50% or more. Further resources: Pavement Surface Condition Field Rating Manual for Asphalt Pavement. <http://co-asphalt.com/resources/maintenance-and-preservation/>

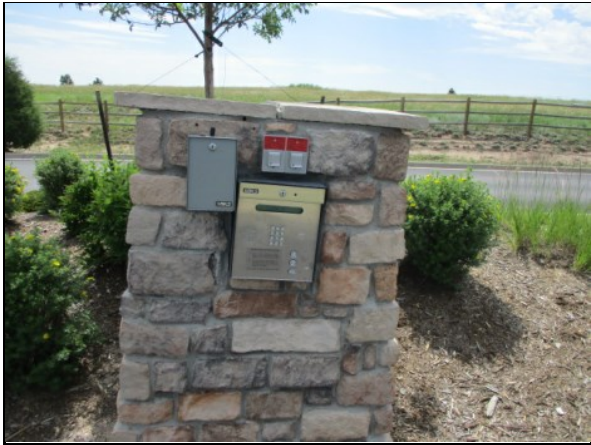
**Comp #: 2501 Access System - Replace**

Comments: Access/intercom system was not inspected internally during site inspection. Should be checked and repaired as needed by servicing vendor as routine maintenance. Individual components can often be replaced for relatively low cost as an Operating expense. Plan for complete replacement at the approximate interval shown here for functional and aesthetic considerations.

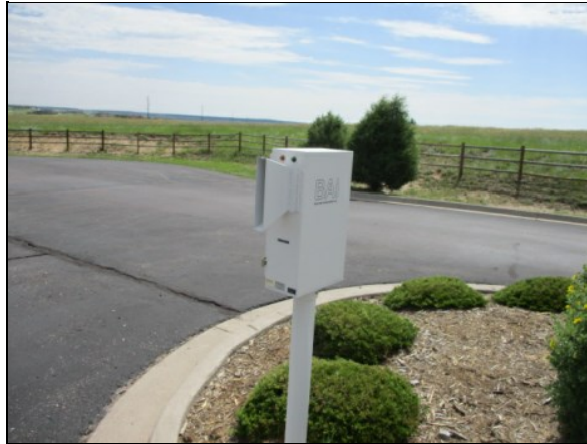
**Comp #: 2503 Card Reader Systems - Replace**

Comments: Should be evaluated and repaired as needed by servicing vendor to ensure proper function. Plan on replacing at the approximate interval shown here. For best pricing and to minimize downtime, plan to replace with other similar components, such as gate operators. Card/fob reader devices were/were observed to be functional during site inspection. Due to use, exposure, and advancements in technology, plan to replace devices and control system at the approximate interval shown here. Individual readers can often be replaced as an Operating expense due to damage or localized failures. To ensure a functional, compatible system and obtain better pricing, plan on replacing all devices together as one project.

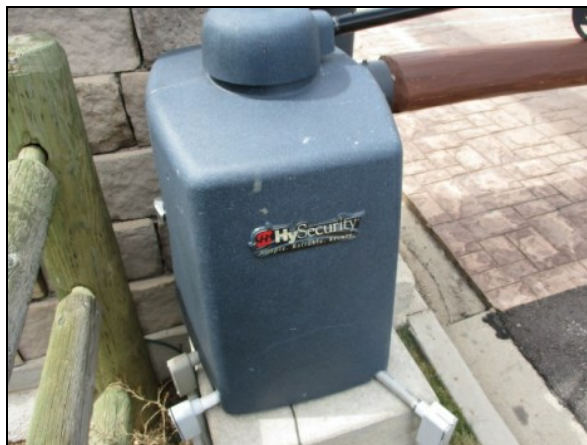
**Comp #: 2509 Gate Operators: HF/TM Entry-Replace**

Comments: HySecurity units. Serial SM02-1718385. Minimal or no subjective/aesthetic value for this component. Useful life is based primarily on normal expectations for service/performance life in this location. Unless otherwise noted, remaining useful life expectancy is based primarily on original installation or last replacement/purchase date, our experience with similar systems/components, and assuming normal amount of usage and good preventive maintenance. Loop detectors are wires under the asphalt or concrete (usually a rectangular pattern in asphalt) and are used to detect vehicles passing over the area, which in turn, signals the gate operator to open or close once the vehicle has passed. Wires are susceptible to moisture penetration through asphalt/concrete. Cycle replacing this component with asphalt/concrete work.

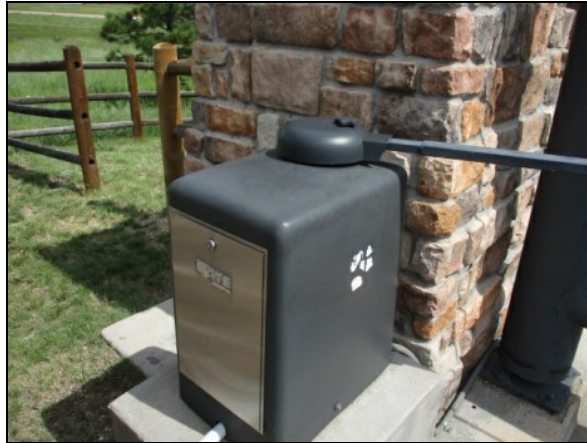
**Comp #: 2509 Gate Operators: RP Entry- Replace**

Comments: Elite gate operators. Minimal or no subjective/aesthetic value for this component. Useful life is based primarily on normal expectations for service/performance life in this location. Unless otherwise noted, remaining useful life expectancy is based primarily on original installation or last replacement/purchase date, our experience with similar systems/components, and assuming normal amount of usage and good preventive maintenance. Loop detectors are wires under the asphalt or concrete (usually a rectangular pattern in asphalt) and are used to detect vehicles passing over the area, which in turn, signals the gate operator to open or close once the vehicle has passed. Wires are susceptible to moisture penetration through asphalt/concrete. Cycle replacing this component with asphalt/concrete work.

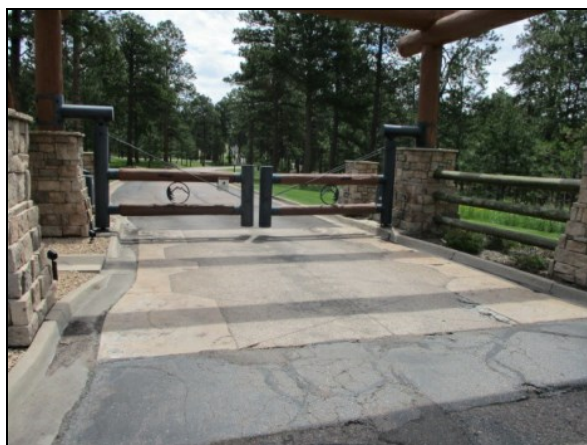
**Comp #: 2511 HF Loop Detectors - Replace**

Comments: Minimal or no subjective/aesthetic value for this component. Useful life is based primarily on normal expectations for service/performance life in this location. Unless otherwise noted, remaining useful life expectancy is based primarily on original installation or last replacement/purchase date, our experience with similar systems/components, and assuming normal amount of usage and good preventive maintenance. Plan to replace at the approximate interval shown here due to use, exposure, and advancements in technology. Should be inspected regularly as an Operating/maintenance expense to ensure proper function. Clean frequently and repair promptly when needed to maintain good appearance.

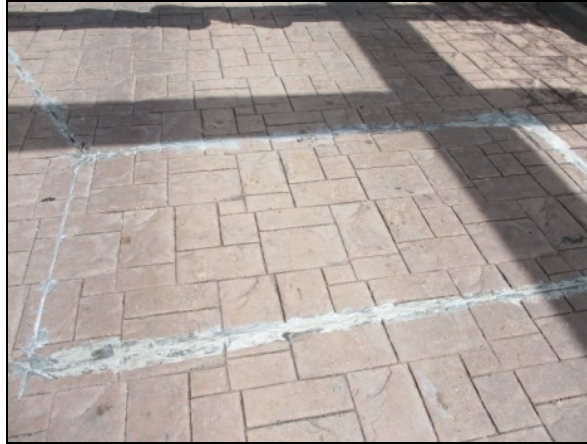
**Comp #: 2511 Loop Detectors - Replace - 20%**

Comments: (3) Detectors are located at each gate. No expectation to replace all detectors at the same time. Loop detectors are wires under the asphalt/concrete (usually a rectangular pattern in asphalt) and are used to detect vehicles passing over the area, which in turn, signals the gate operator to open or close once the vehicle has passed. Wires are susceptible to moisture penetration through asphalt. Cycle replacing this component with asphalt work.

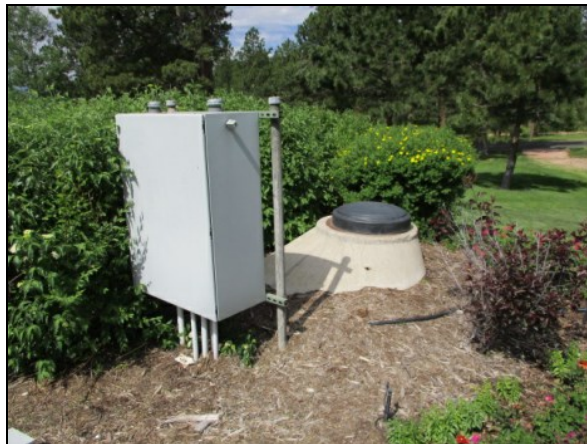
**Comp #: 2535 Clubhouse Well Pump - Replace**

Comments: No problems reported with the pump at the time of the inspection. Pump was not tested during site inspection, and is assumed to be functional unless otherwise noted. Should be inspected, tested and repaired as needed on a regular basis by qualified vendor to ensure optimal performance. Over time, replacement parts may not be available and the association may need to replace the entire assembly prior to actual functional failure as a safety precaution.

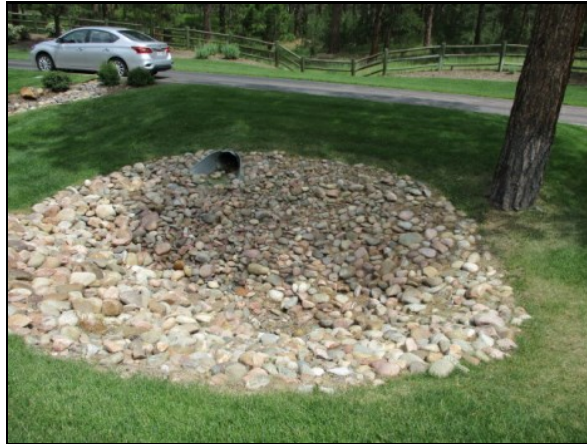
**Comp #: 2535 Entry Pumps - Replace**

Comments: No problems reported with the pump at the time of the inspection. Pump was not tested during site inspection, and is assumed to be functional unless otherwise noted. Should be inspected, tested and repaired as needed on a regular basis by qualified vendor to ensure optimal performance. Over time, replacement parts may not be available and the association may need to replace the entire assembly prior to actual functional failure as a safety precaution.

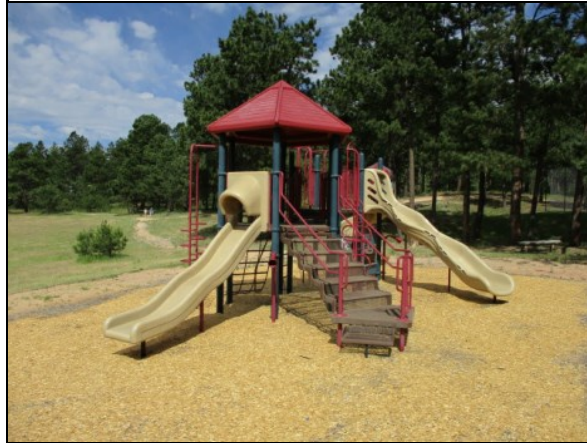
### Comp #: 2601 Play Equipment - Replace

Comments: Play structure appears in overall fair condition with the exterior paint showing signs of minor fading. The remaining useful life was extended based on the appearance of the structure. Recommend the following: 1) Paint to maintain the exterior surface integrity (use operational budget to maintain). 2) Conduct regular inspections by qualified personnel to maintain and inspect equipment for hazards. Manufacturer's maintenance instructions and recommended inspection schedules should be strictly followed.

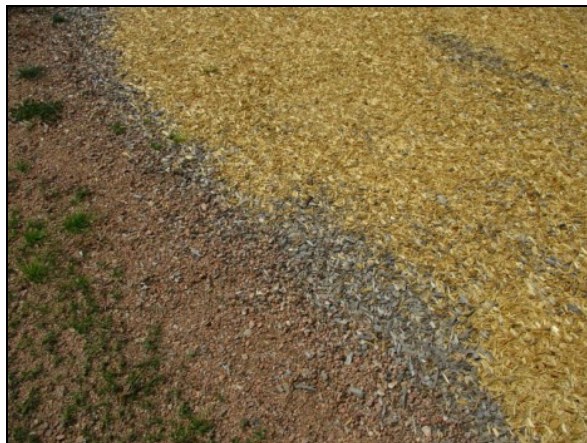
### Comp #: 2603 Play Surface - Replace

Comments: Coverage was generally sufficient, but small areas of heavy use were noted. Playground surfaces should be inspected regularly for hazards, slip and fall risks, etc. Plan to replace at the approximate interval shown here for aesthetic and functional reasons. When evaluating replacement options, the Association should consult with vendors to ensure adequate protection from falls. Costs shown are based on replacement with same surface type unless otherwise noted.
